NEW MEXICO ENVIRONMENT DEPARTMENT

Re: Ranchland Utilities WWTP, Minor, Individual Permit; SIC 4952; NPDES Compliance Evaluation Inspection; NPDES Permit No. NM0030368; Inspection Date: April 11, 2018

**Compliance Evaluation Inspection
Ranchland Utilities Water Reclamation Facility
NPDES Permit No. NM0030368
April 11, 2018**

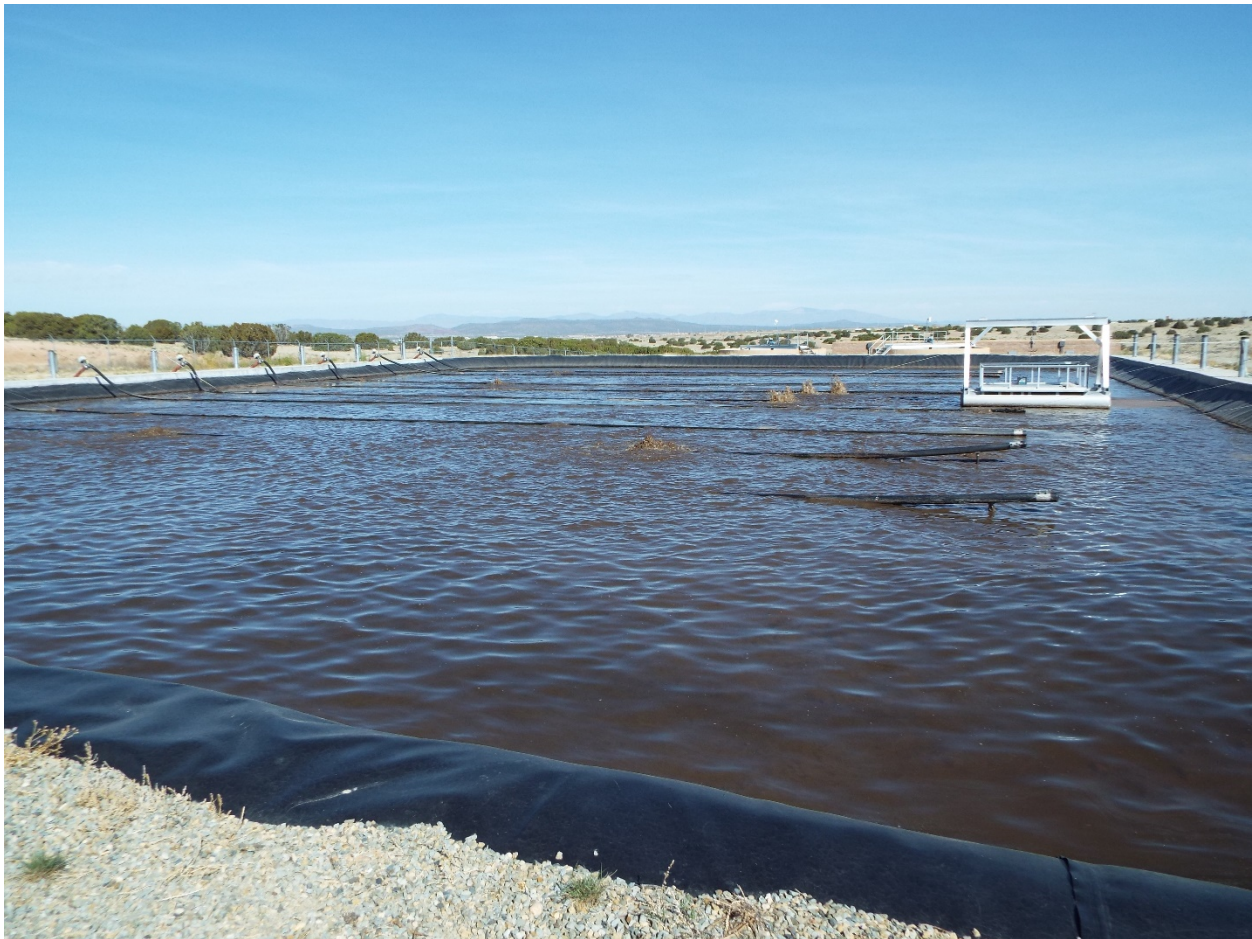
NMED/SWQB
Official Photograph Log
Photo # 2

The Biolac® system has floating solids as well as noticeable grease. Some of the fine bubble diffusers were malfunctioning.

Photographer: Daniel Valenta	Date: April 11, 2018	Time: 0942 Hours
City/County: Santa Fe / Santa Fe		State: New Mexico
Location: Ranchland Utilities		
Subject: Biolac extended aeration pond – BioFuser fine bubble diffuser assemblies appear to be nonfunctional in various areas of the pond.

The Biolac® system utilizes a longer sludge age than other extended aeration systems. The sludge age in this particular system efficiently allows for a 30-70 day sludge time. It appears that the sludge age in this system is beyond the 70-day efficiency time for the Biolac®. The operator stated that the system is producing minimal Biochemical Oxygen Demand (<2 mg/L) and Total Suspended Solids (<2 mg/L). It may be beneficial for the system to remove some of the solids to allow a more efficient aeration.

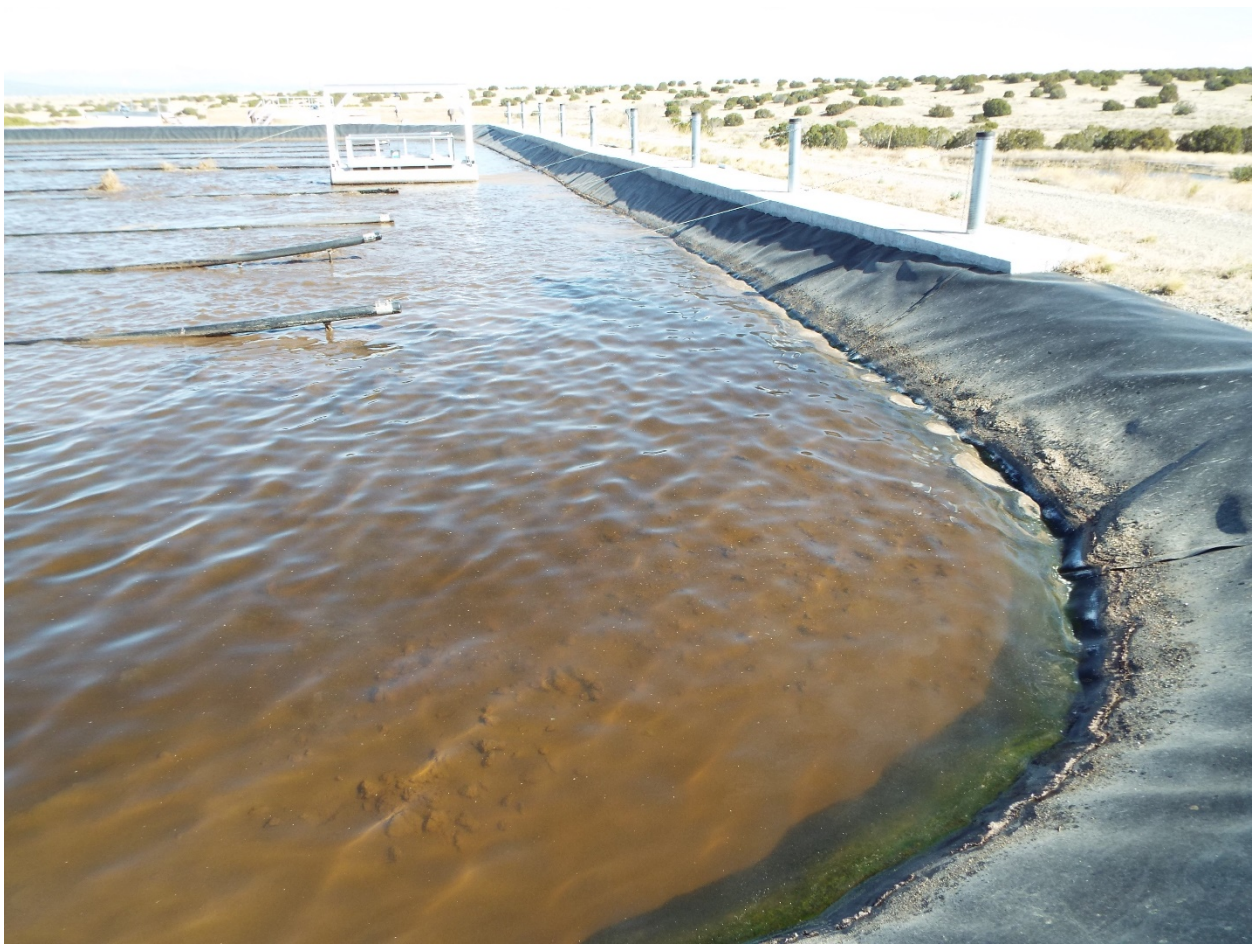
NMED/SWQB
Official Photograph Log
Photo # 3

Photographer: Daniel Valenta	Date: April 11, 2018	Hours: 0943 Hours
City/County: Santa Fe / Santa Fe		State: New Mexico
Location: Ranchland Utilities		
Subject: Biolac pond – significant solids in pond > 30-70 days

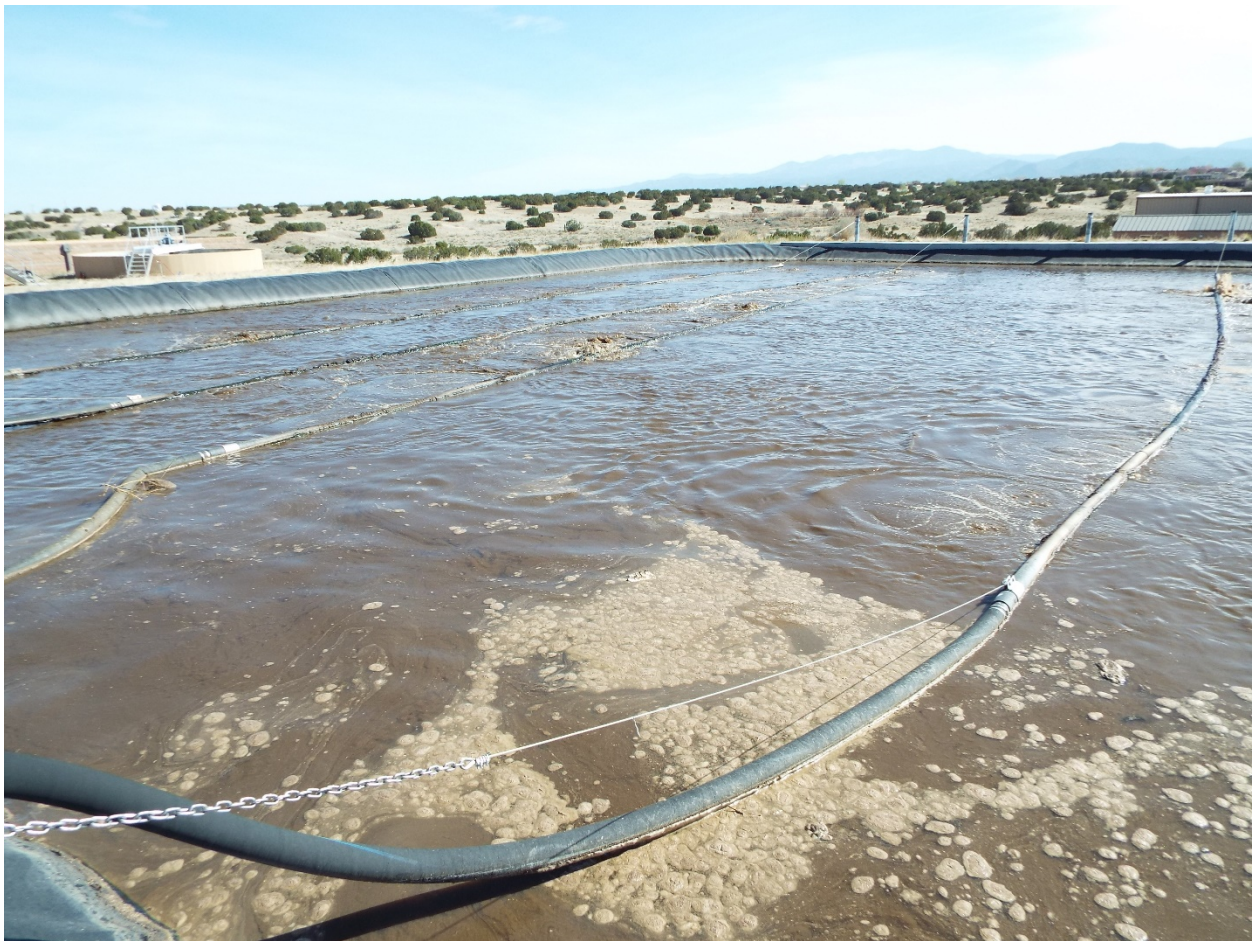
NMED/SWQB
Official Photograph Log
Photo # 4

Photographer: Daniel Valenta	Date: April 11, 2018	Hours: 0952 hours
City/County: Santa Fe / Santa Fe		State: New Mexico
Location: Ranchland Utilities		
Subject: Grease in pond

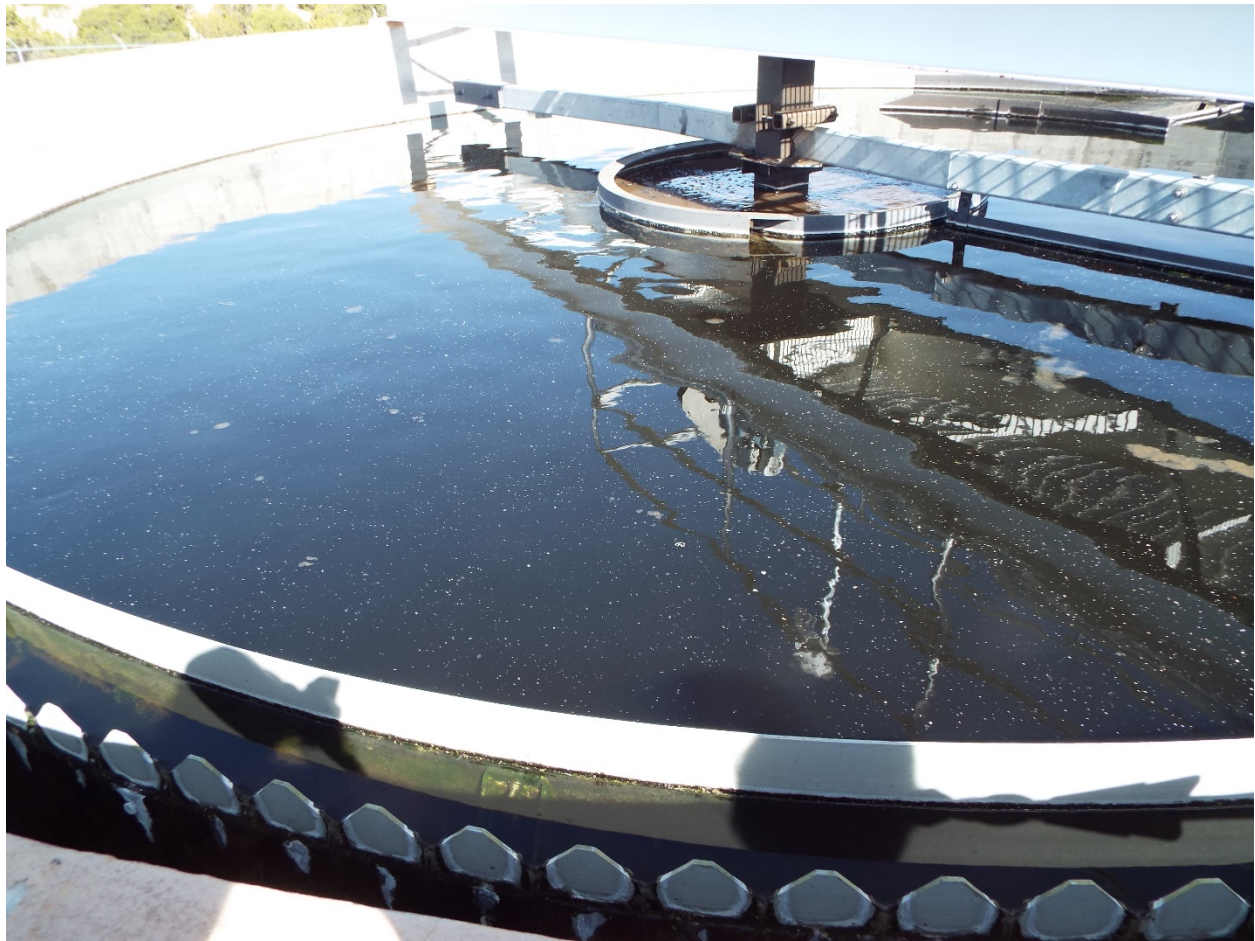
NMED/SWQB
Official Photograph Log
Photo # 5

Photographer: Daniel Valenta	Date: April 11, 2018	Hours: 0954 hours
City/County: Santa Fe / Santa Fe		State: New Mexico
Location: Ranchland Utilities		
Subject: West Clarifier with appearance of ashing.

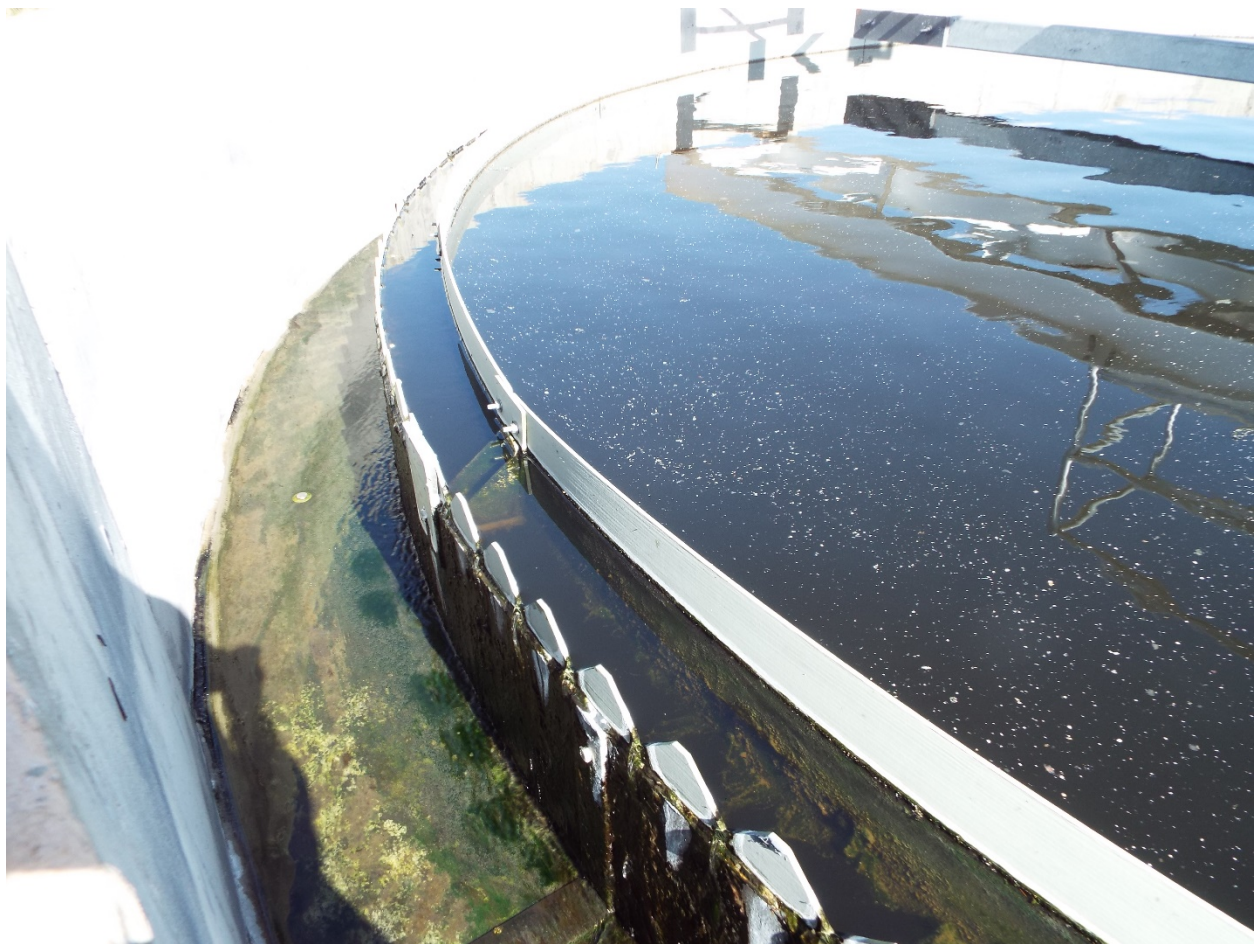
NMED/SWQB
Official Photograph Log
Photo # 6

Photographer: Daniel Valenta	Date: April 11, 2018	Hours: 0954 Hours
City/County: Santa Fe / Santa Fe		State: New Mexico
Location: Ranchland Utilities		
Subject: Short-circuiting occurring over weirs, algal growth.

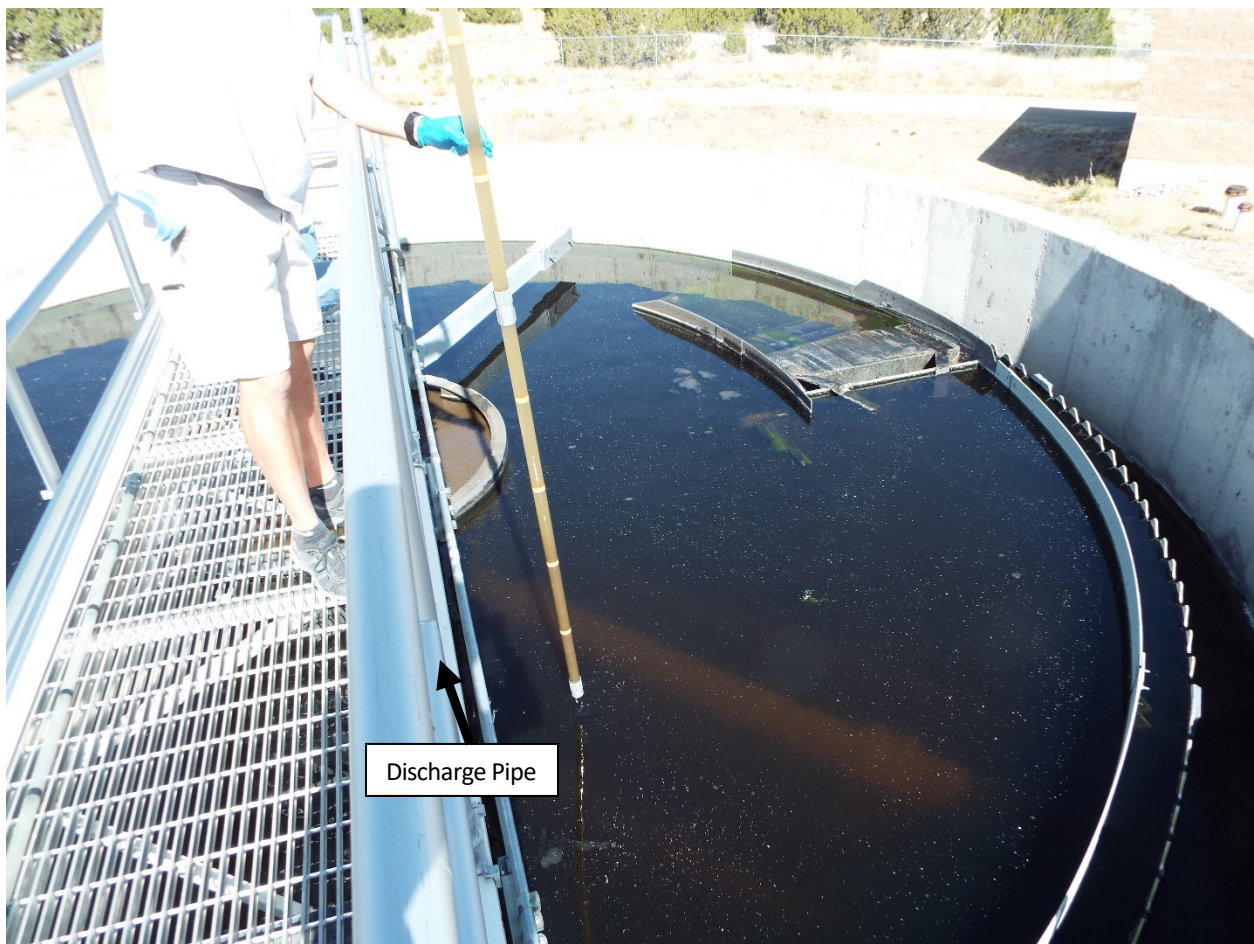
NMED/SWQB
Official Photograph Log
Photo # 7

Photographer: Daniel Valenta	Date: April 11, 2018	Hours: 0956 Hours
City/County: Santa Fe / Santa Fe		State: New Mexico
Location: Ranchland Utilities		
Subject: Sludge judge reading of clarifier

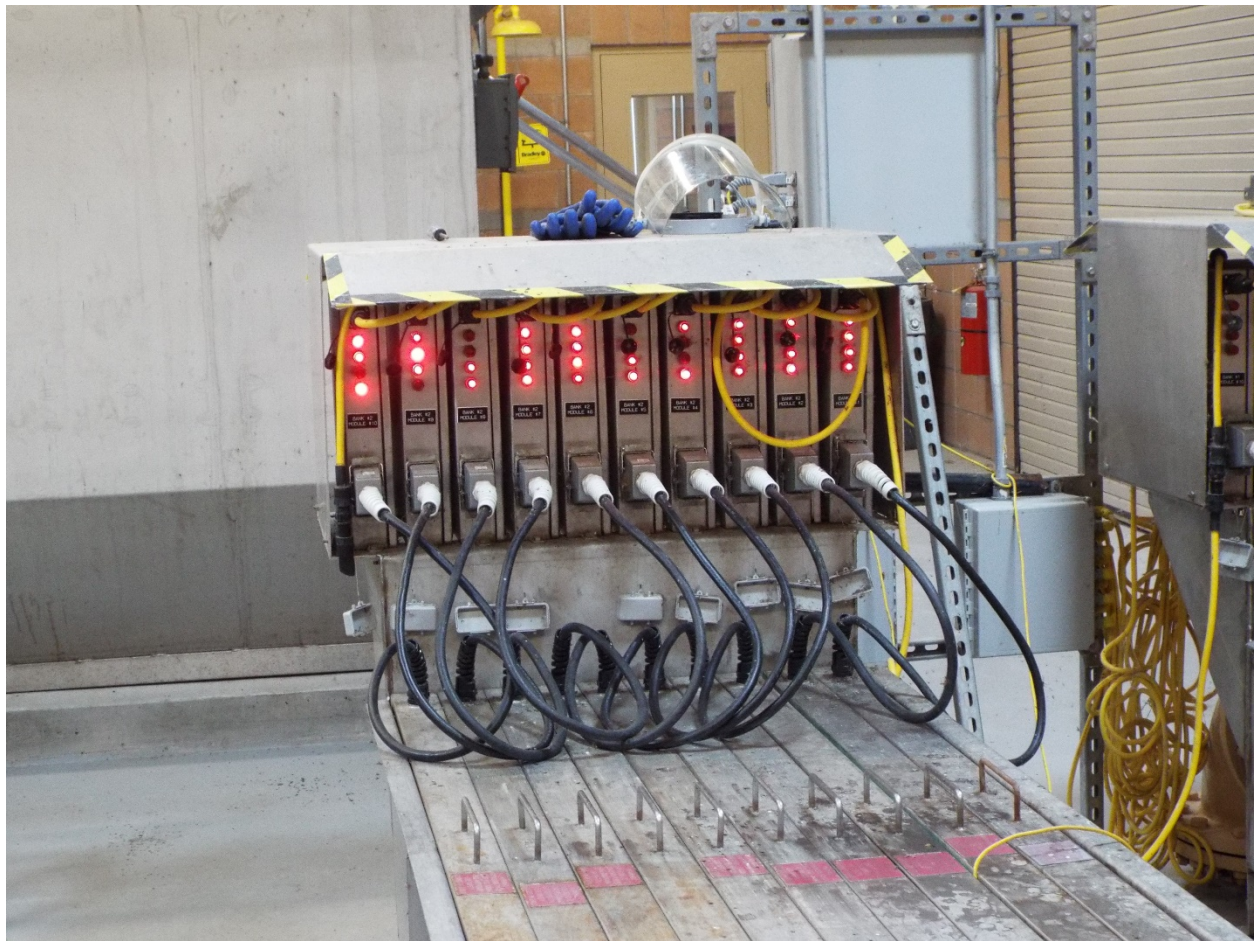
NMED/SWQB
Official Photograph Log
Photo # 8

Photographer: Daniel Valenta	Date: April 11, 2018	Hours: 1000 Hours
City/County: Santa Fe / Santa Fe		State: New Mexico
Location: Ranchland Utilities		
Subject: UV lights – several banks out of order (88% UV)

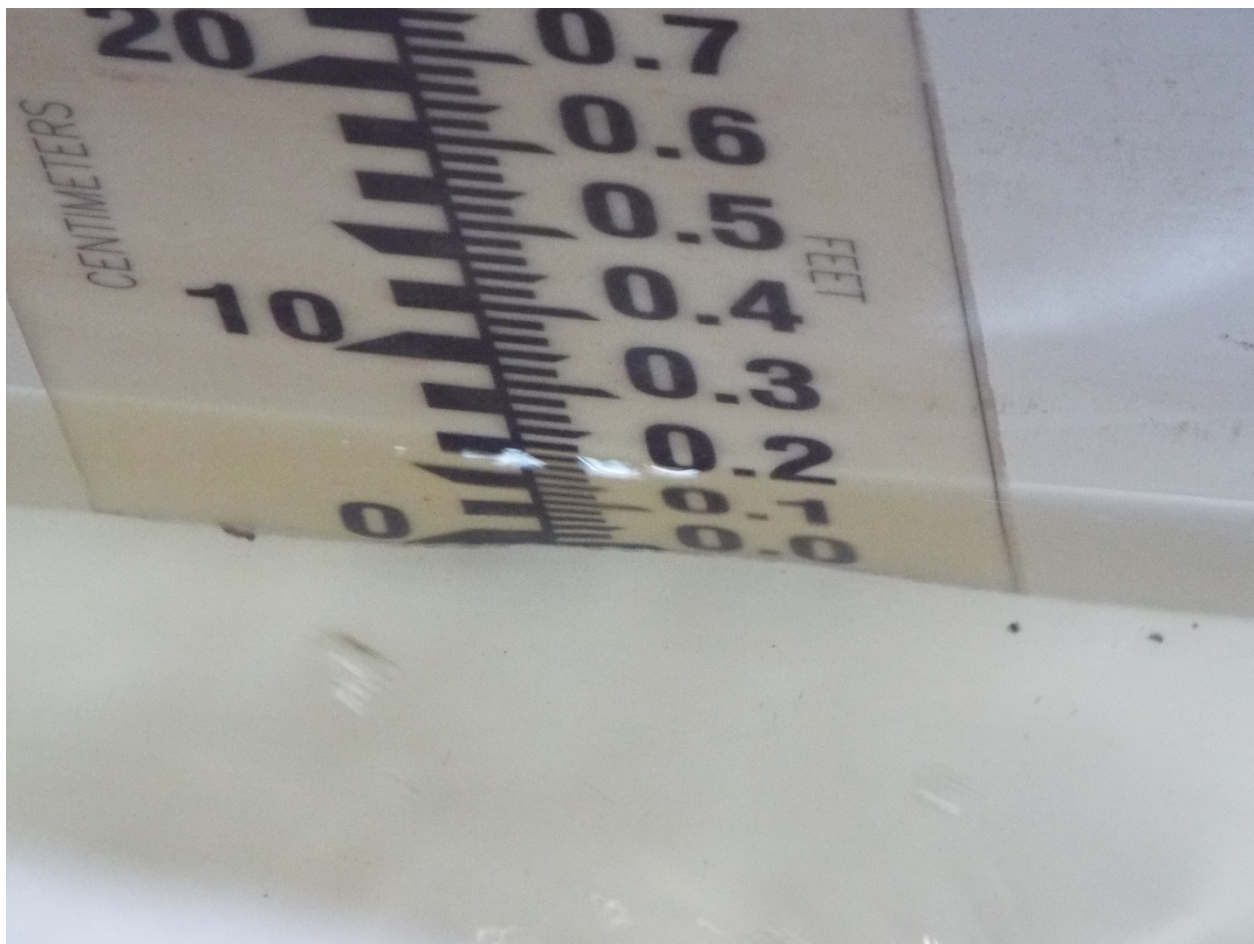
NMED/SWQB
Official Photograph Log
Photo # 9

Photographer: Daniel Valenta	Date: April 11, 2018	Hours: 1009 Hours
City/County: Santa Fe / Santa Fe		State: New Mexico
Location: Ranchland Utilities		
Subject: Staff gage reading

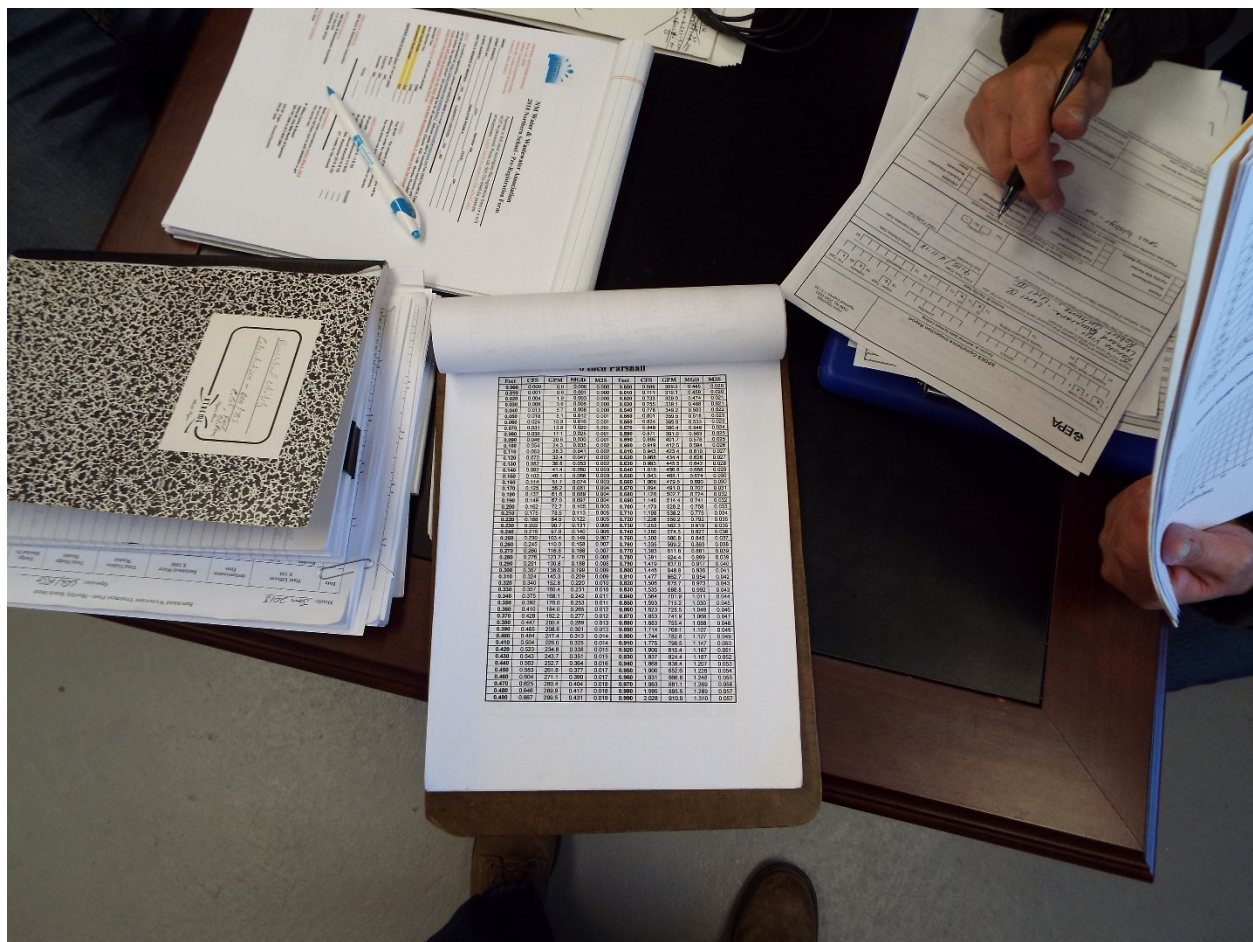
NMED/SWQB
Official Photograph Log
Photo #10

The totalizer is placed in an improper location; the totalizer is located in the wrong position relative to the primary device. It is placed relatively close to the discharge point in an area of turbulence. It is imperative that the totalizer be placed in the appropriate manner to do calibration checks.

Photographer: Daniel Valenta	Date: April 11, 2018	Hours: 1009 Hours
City/County: Santa Fe / Santa Fe		State: New Mexico
Location: Ranchland Utilities		
Subject: 6"Parshall Flume Conversion Sheet (0.2 = 72.7 GPM) Totalizer was reading 100 GPM

The permittee is required to calibrate their totalizer at least annually by an outside representative to insure accurate flow measurement. Accurate flow measurement is required when doing mass loading calculations.
